## McFarland High School Construction Update!

Over the past two weeks, the McFarland High School project has seen major steps towards completion. The pool deck has been entirely poured! With this poured, joist and deck painting and MEP work can begin in the area. Underneath the mezzanine, masonry walls are complete creating the changing area, pool entrance, and Pool Directors office. In the lobby, MEP rough-ins, bar joists, and steel studs are ongoing. Steel work is ongoing in the PAC as catwalks are being installed above the stage. The mud-slab, and access ramp in the PAC have also been poured. The mud-slab will be used by many trades that need to complete overhead work in the PAC. Behind the stage, masonry work is ongoing as the walls for the dressing room and green room are nearing completion. In the Multi-Purpose room, the block walls are complete and have been topped out with steel studs.

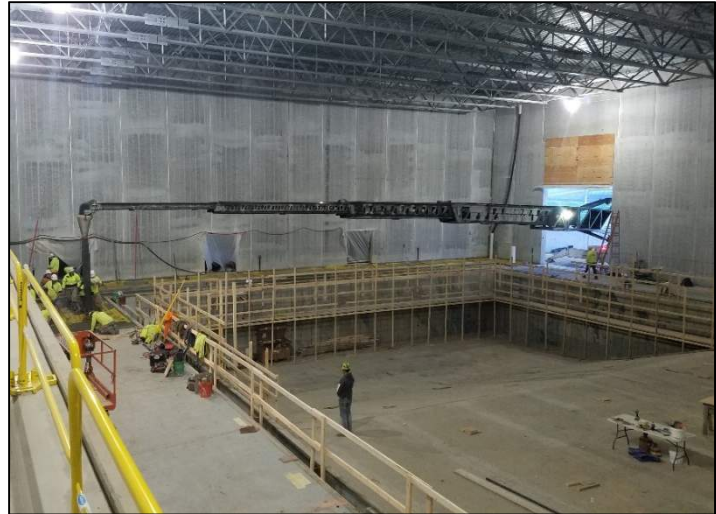
Due to limited access in the Pool, a conveyor was used to pour the final segment of concrete. This conveyor spanned just over 100 feet!

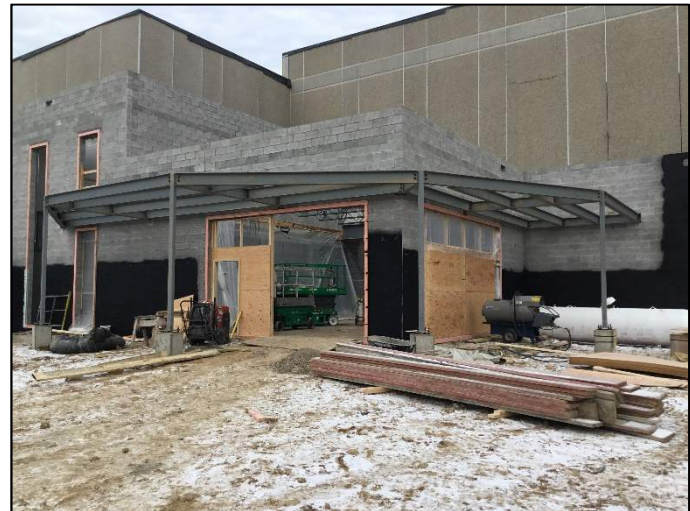
The vestibule overhang steel structure is complete. This overhang will be finished with metal coping around the edge, and slotted metal panels underneath.

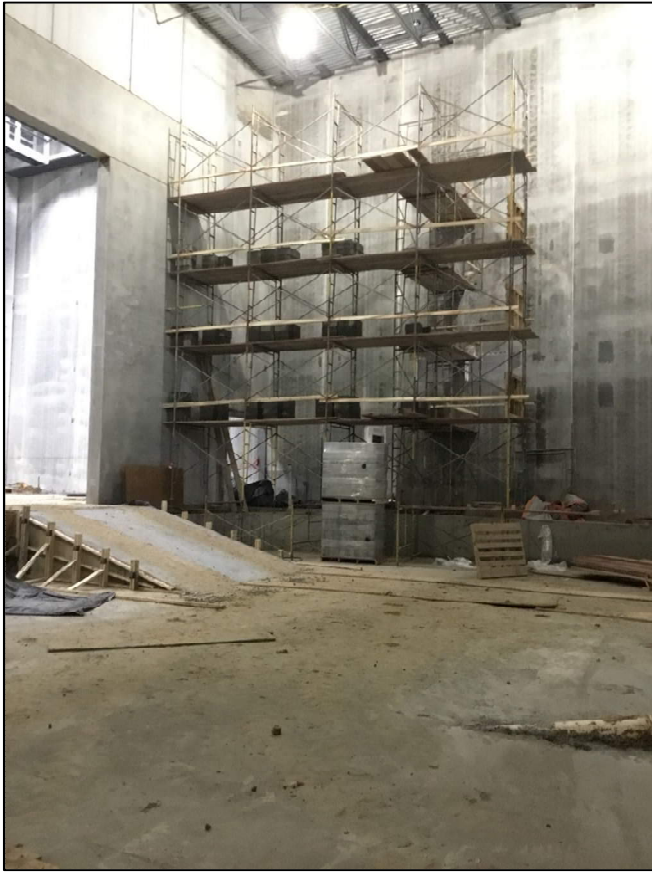
The masons are preparing to build the PAC cheek walls. After these walls are built, the side circulation concrete can be poured.
